Ultrasonic Testing:
Purpose, Process, and Profits
Lab #5 Cypress Room

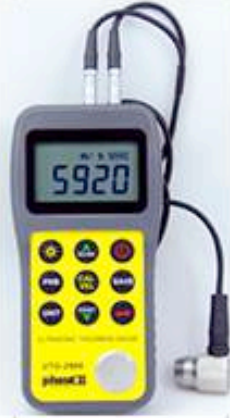
Estone	Phase II	DeFelsko PosiTector	DeFelsko PosiTector

Order Code	UTG GM100	UTG 2900	UTG C3	UTG M3
Display	Digital	Digital	LCD	LCD
Included Probe	Yes	Yes	Yes	Yes
Memory	12 readings	20 Batches	1,000 Bathces	1,000 Batches
Thru-Paint Capability (Multiple Echo)	Yes	Both Avalable	No	Yes
Accuracy	±5% thickness +.001"	±5% thickness +.001"	±.001	±.001"
Measurement Range* - Multiple Echo	.05"-8.86"	.118"-2.35"	.100"-2.500"	.100"-2.500"
MSRP	\$120	\$900	\$1,300	\$2,000
How to Buy	Amazon	Phase2Plus .com	Defelsko	Defelsko

- Ultrasonic Wall Thickness gauge
 - Capability to store readings in batches of at least 16.
 - Capability to transfer data to computer.
 - Have bin problems with Dual Eco Probes
- DeFelsko UTG C3
 - Transfers data to computer via wireless connection
 - Stores up to 1,000 batches of 100 readings each

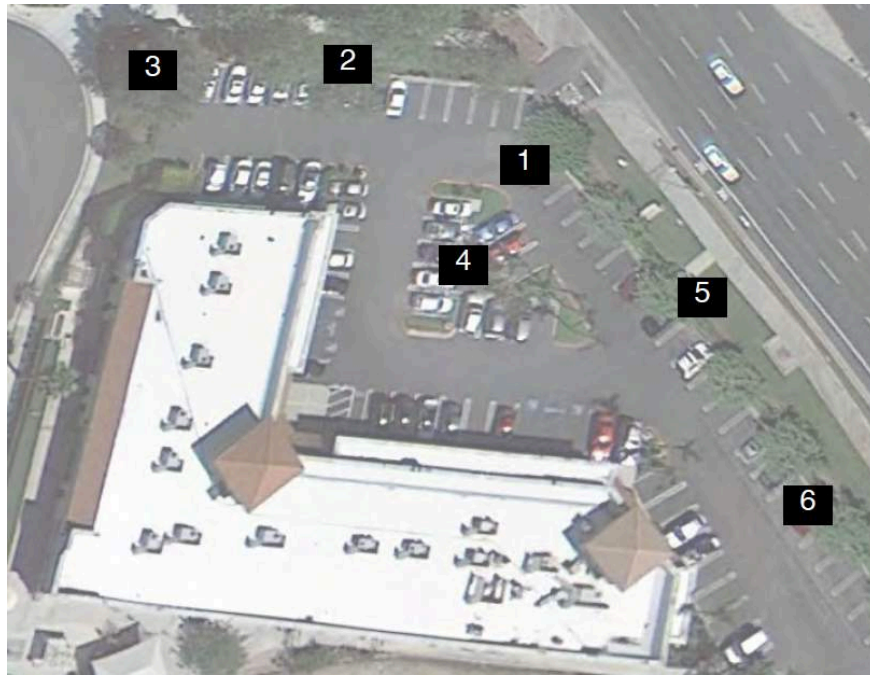
Process: Site Map

- Create accurate site map.
 - Satellite view helps
 - Ensure room for additional poles
 - Poles Numbers can be left blank so tech can decide order

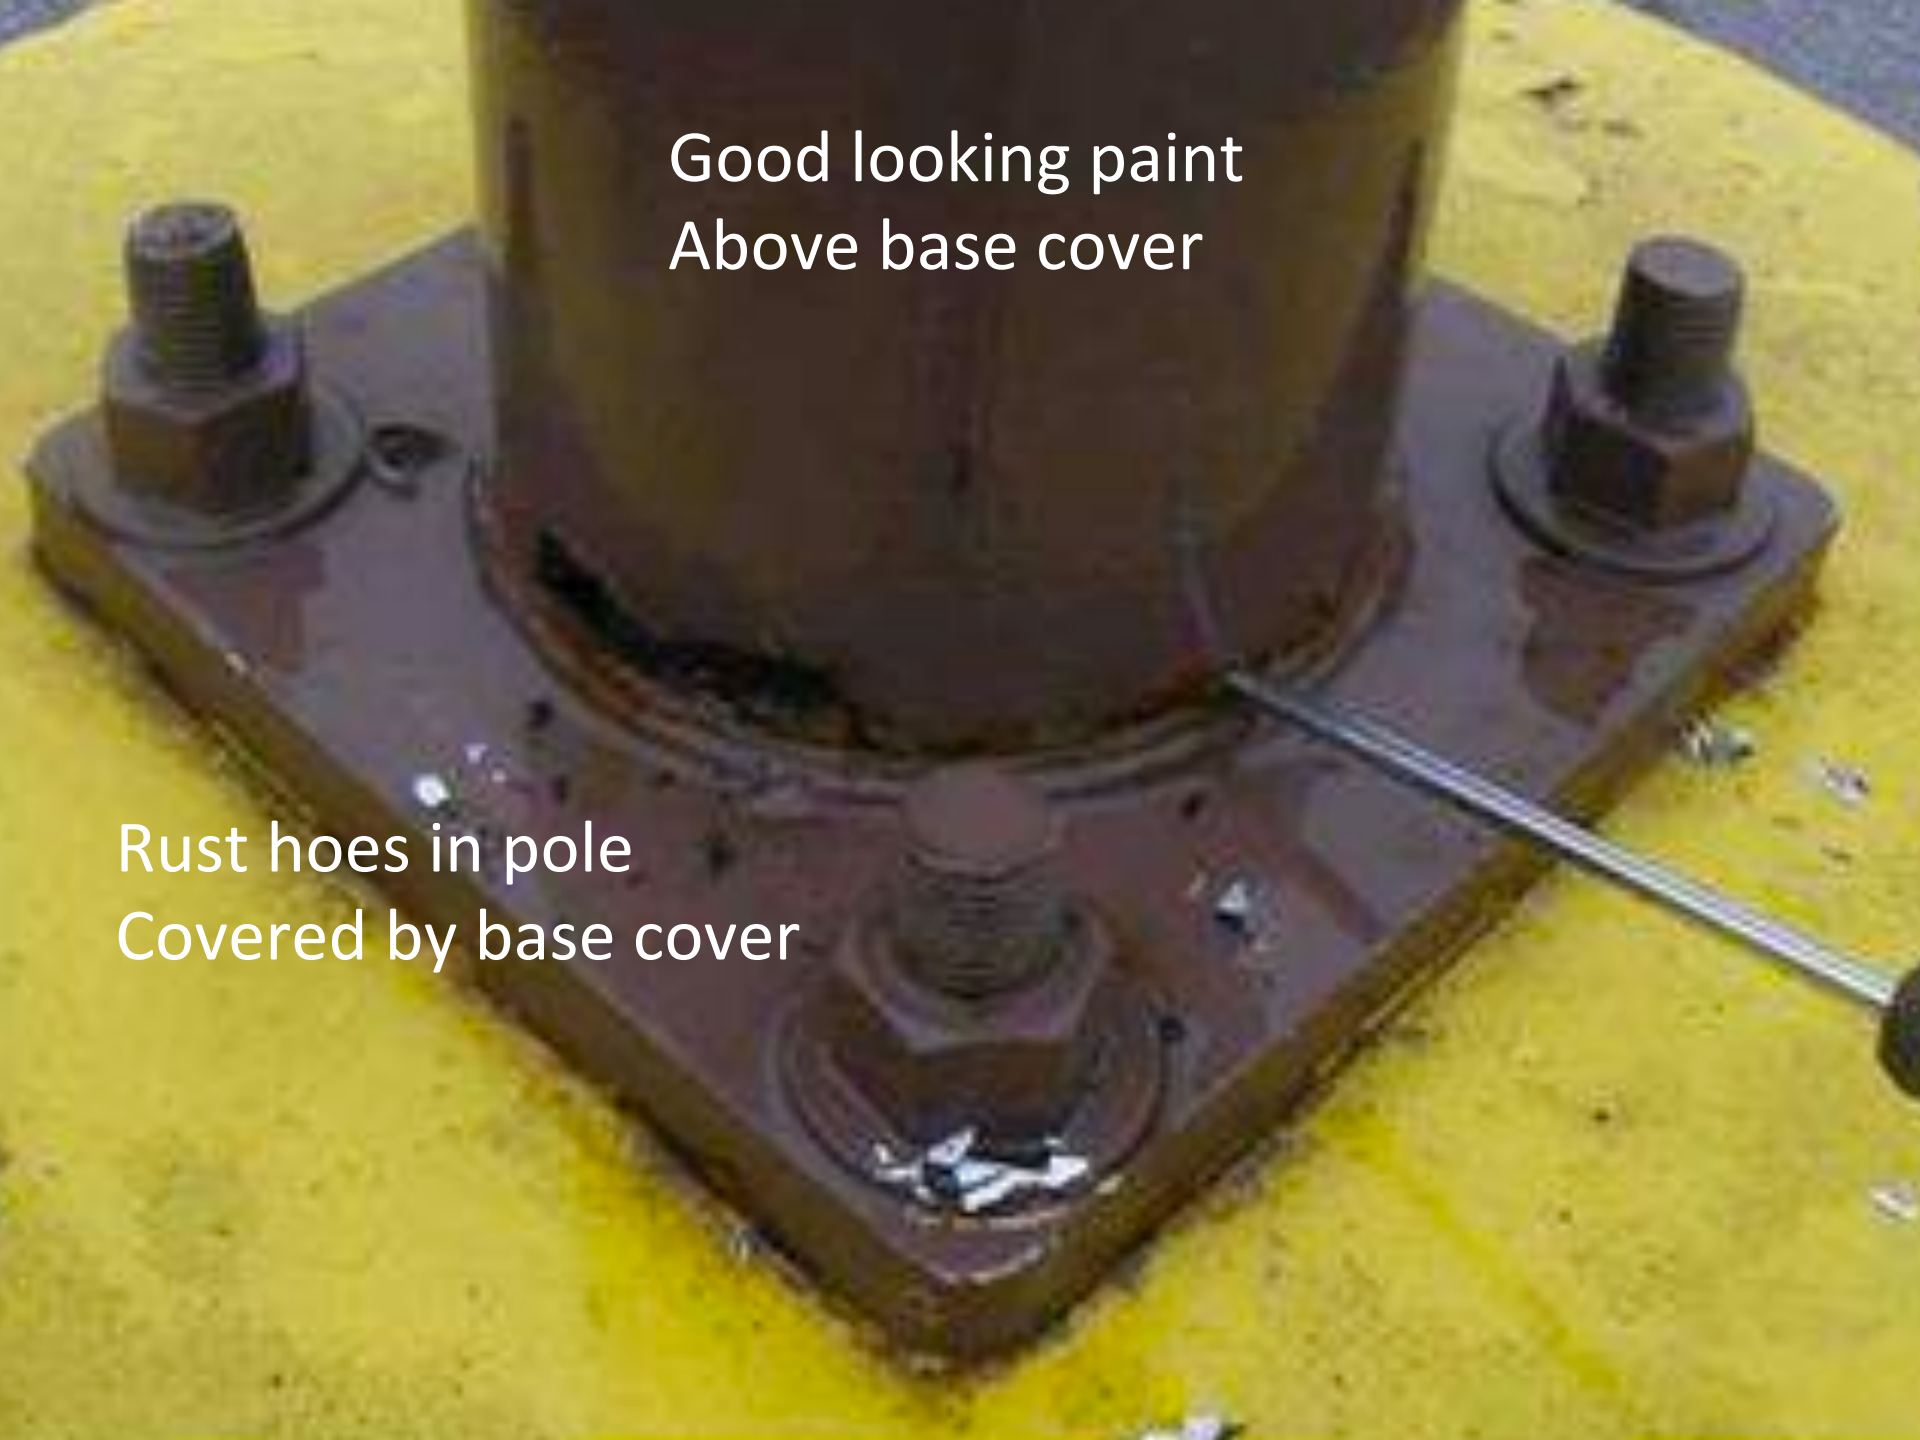
Good looking paint
Above base cover

Rust hoes in pole
Covered by base cover

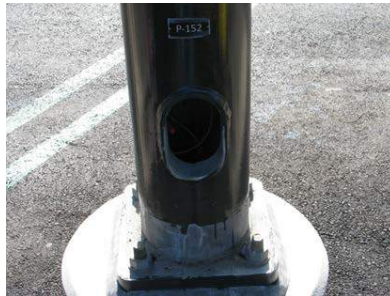
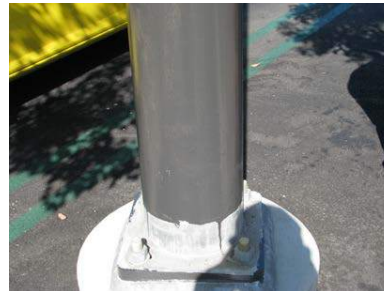
Process: Compiling the Report

POLE #	POLE SIDE #	TEST POINT ID	TEST READING	NOMINAL THICKNESS	DIFFERENTIAL VALUE	VISUAL INSPECTION AND RECOMMENDATION
P-152	1	A	0.130	0.133	-2.22%	Pole is Galvanized, protecting the pole from rust. New base cover installed.
		B	0.130	0.133	-2.22%	
		C	0.130	0.133	-2.22%	
		D	0.130	0.133	-2.22%	
	2	A	0.130	0.133	-2.22%	
		B	0.130	0.133	-2.22%	
		C	0.134	0.133	0.74%	
		D	0.130	0.133	-2.22%	
	3	A	0.130	0.133	-2.22%	
		B	0.134	0.133	0.74%	
		C	0.138	0.133	3.70%	
		D	0.134	0.133	0.74%	
	4	A	0.134	0.133	0.74%	Recommendation: Paint base cover
		B	0.138	0.133	3.70%	
		C	0.142	0.133	6.67%	
		D	0.134	0.133	0.74%

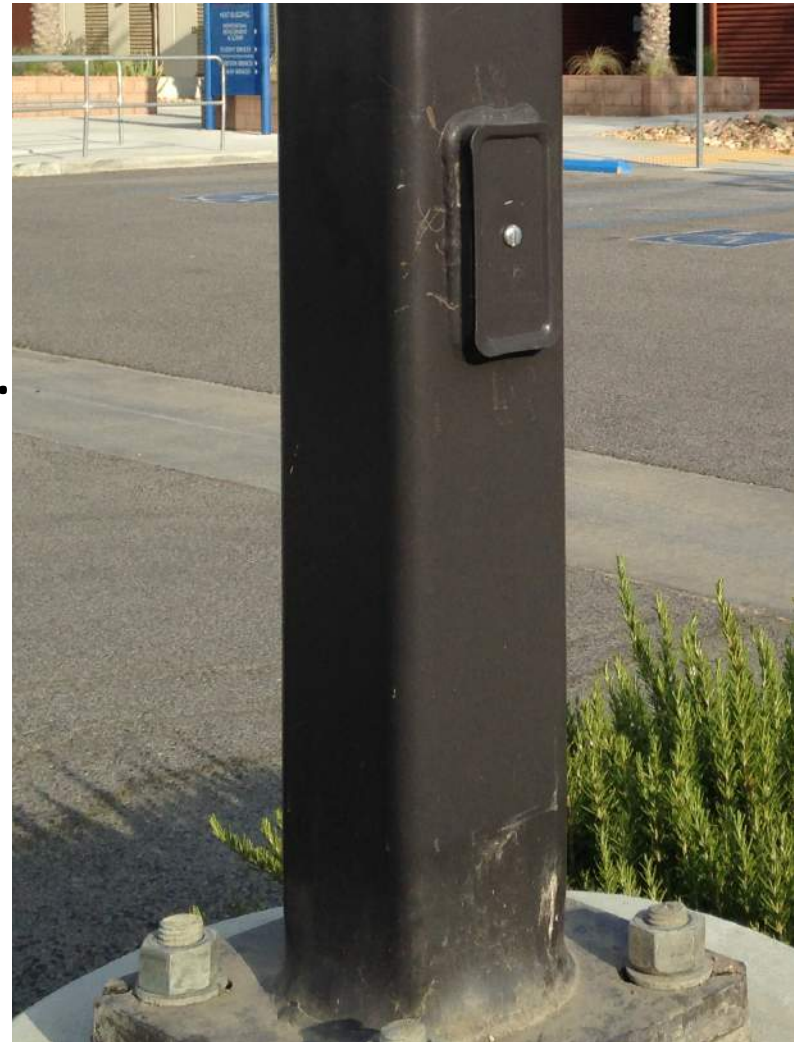
Process: Pole Condition

- Good
 - Pole shows no signs of surface or internal rust.
 - Test readings are consistent.
 - Water can drain out from inside pole.
 - There is no immediate action needed
 - Retest the pole in 2 years

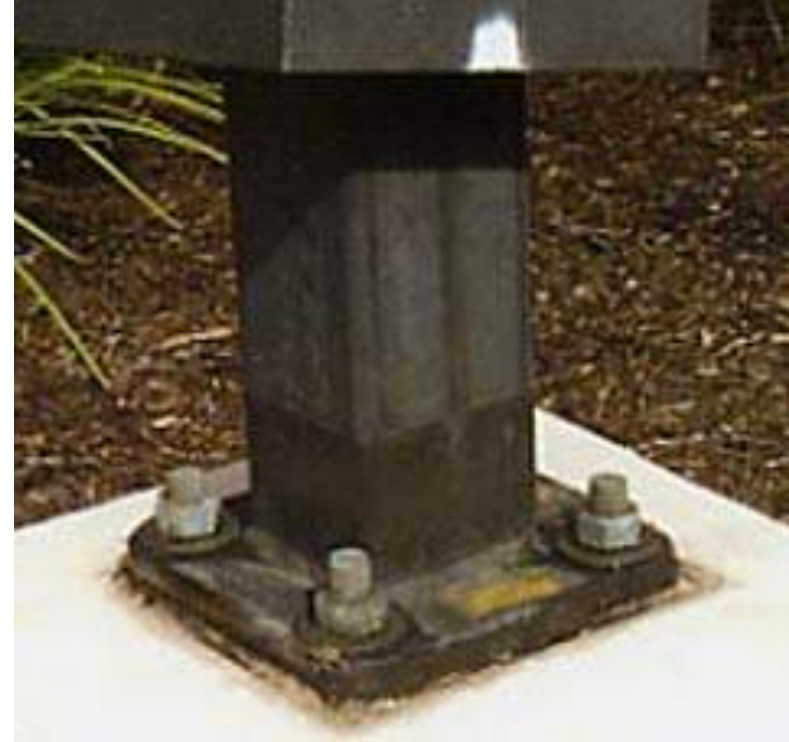
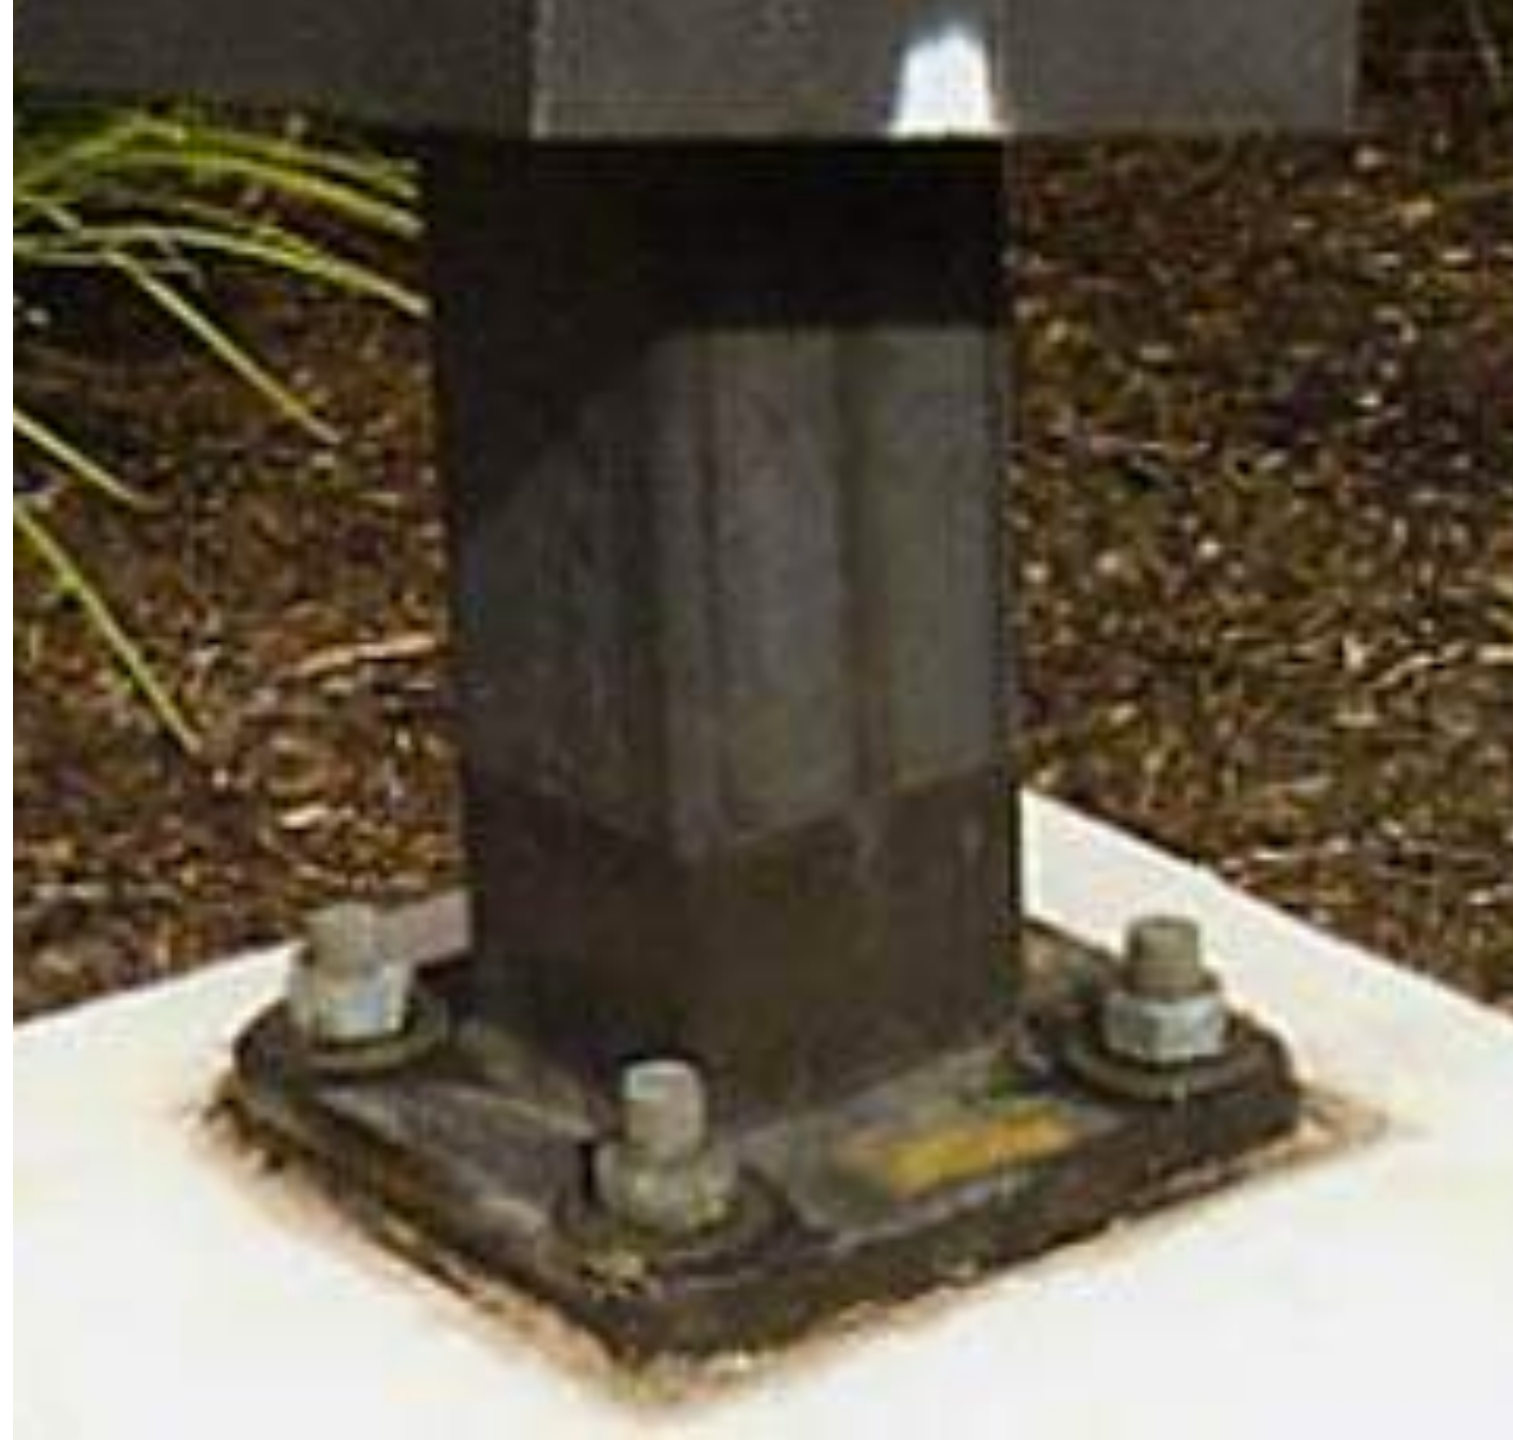
Process: Pole Condition

- Marginal
 - Minimal signs of rust.
 - Ringing with hammer/punch.
 - Test readings are consistent.
 - Water cannot drain.
- Remove surface rust, repaint, & create water drainage.
- Retest the pole in 1 year

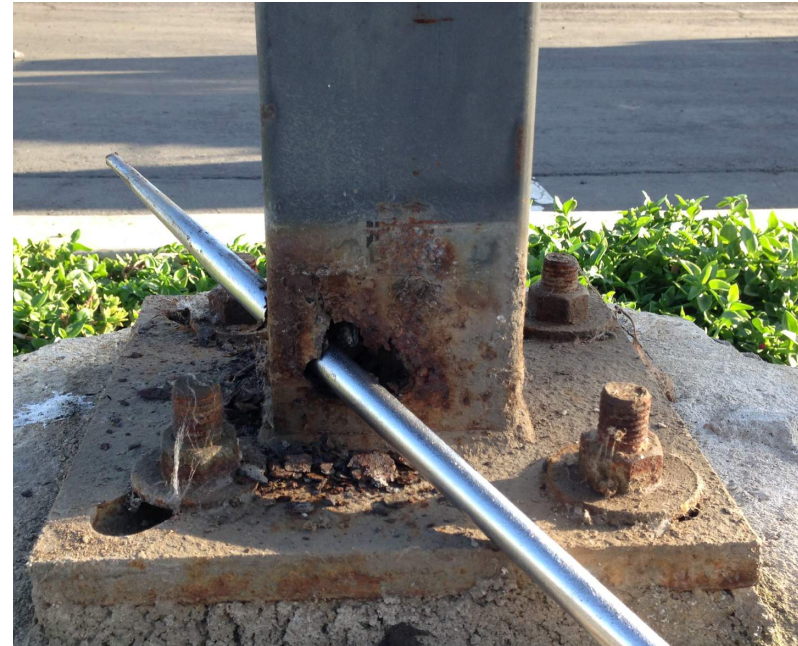
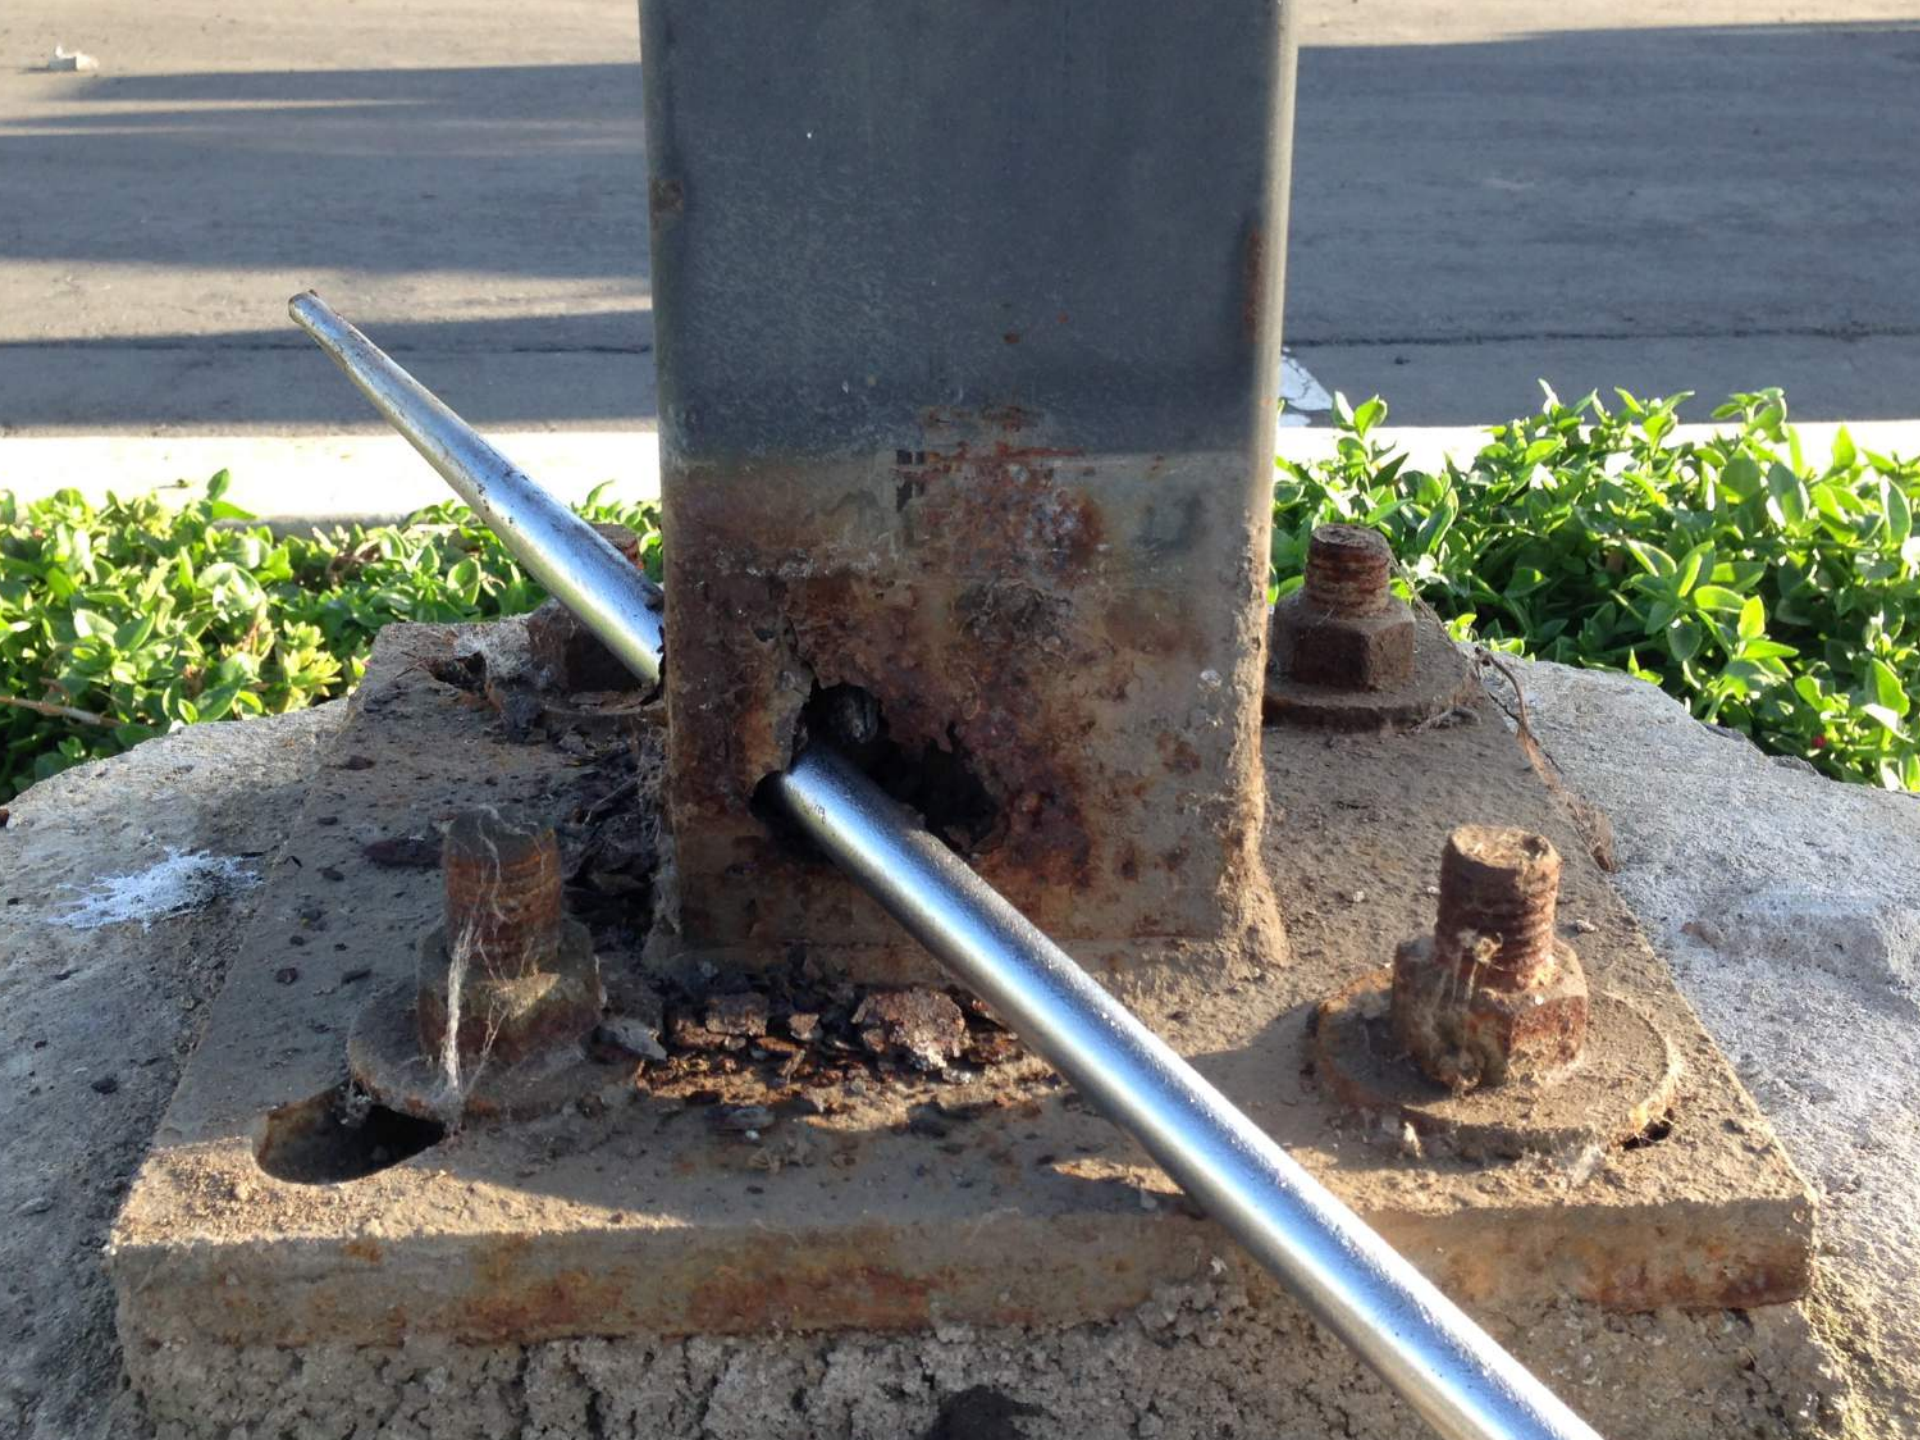
Process: Pole Condition

- Bad
 - Rust showing through paint.
 - Flaking rust.
 - Readings show variances.
 - Metal thuds or dents when hit with hammer/punch.
 - Holes in the pole.
 - Repair immediately.
